# **2017 QUARTERLY COMPLIANCE REPORT**

**Quarter No. I**

**Tule Wind Energy Project**

# 2017 Quarterly Compliance Report (Q1) for the Tule Wind Energy Project

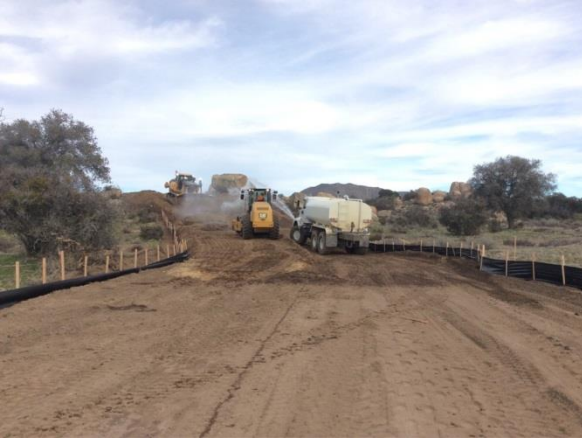
**Photo 1:** Clearing and grading activities observed within the staked limits of disturbance in accordance with MM BIO-1A. Water trucks in use for dust control in accordance with MM-AQ-1.

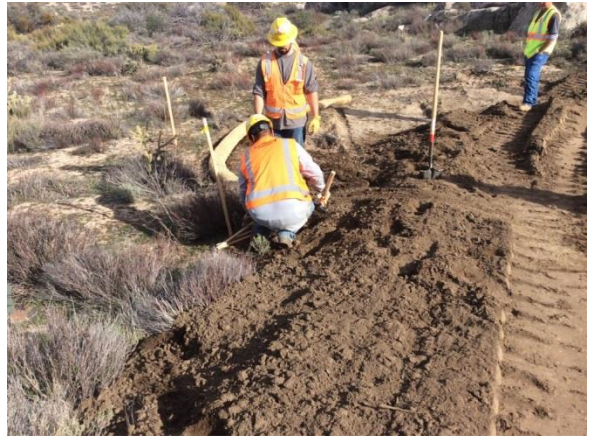
**Photo 2:** Crews installing additional straw wattles along McCain Valley Road in accordance with the SWPPP and MM HYD-1.

Due to the above average rainfall, numerous erosion and sediment control devices were damaged or in need of maintenance and repair. In several cases, the erosion and sediment control devices were laden with sediment and in other cases were ineffective as water was flowing beneath the devices rather than through the device. Each of these issues were documented and reported to Tule Wind LLC. Tule Wind LLC has assigned a dedicated crew to address repair, maintenance, and installation of erosion and sediment control devices.

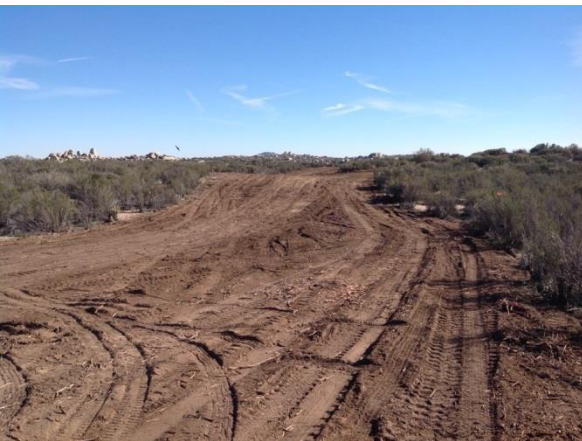
**Photo 3:** On 1.18.17, approximately 11,700 square feet of vegetation was mulched outside of the currently approved limits of disturbance. BLM issued a "Noncompliance" in accordance with Section 5.2 of the ECMP.

| Incident Number | Date of Incident | Description of Incident | Description of Corrective Action |
|---|---|---|---|
| 06 | 1.18.17 | On Wednesday, 1.18.17 the BLM's third party ECM observed a compliance issue where vegetation had been grubbed within the proposed disturbance limits of Variance Request 003, which had not yet | Tule Wind LLC shut down the site to assess this incident. At the time, the only remaining variance staking in the field was on the G-line associated with the last area in Variance |

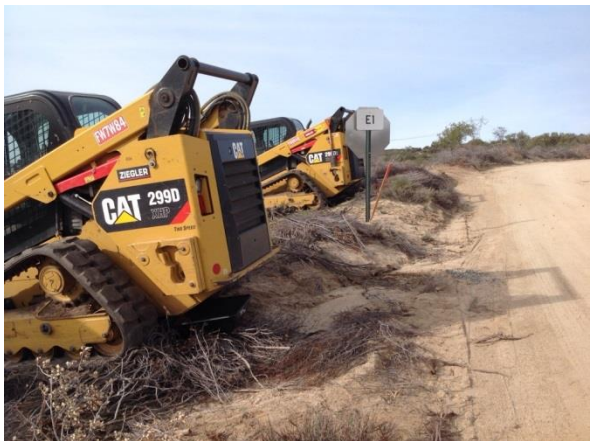
**Photo 4:** ECMs observed containment drip pans under parked equipment to prevent potential leaking equipment from staining soils in accordance with MM HAZ-1A and the Hazardous Materials Management Plan.

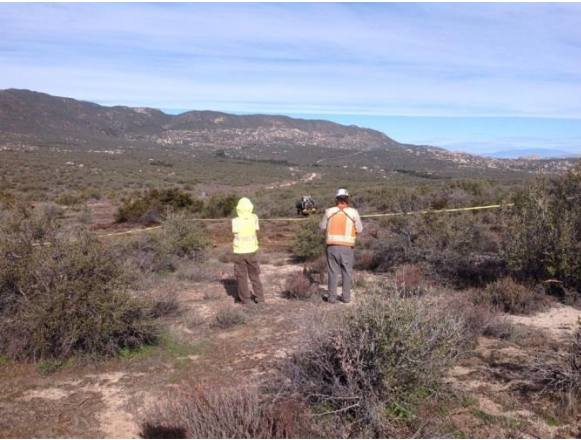
**Photo 5:** Biological monitors were present to observe grubbing activities in accordance with MM BIO-1C. All observed activities occurred within the disturbance limits in accordance with MM BIO-1A. Yellow tape was strung between disturbance limit stakes to increase visibility of limits for masticator operators in accordance with the NTP issued on February 1, 2017.

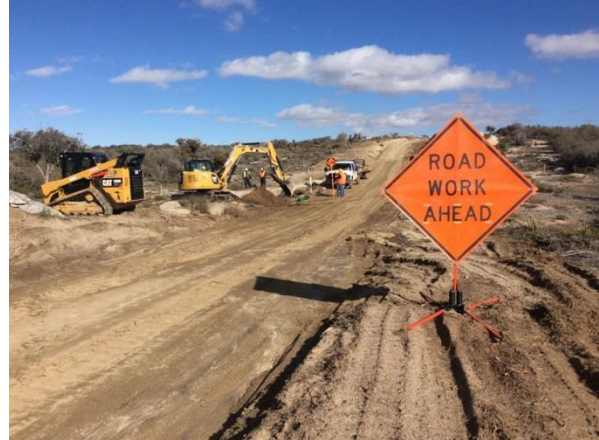
**Photo 6:** Traffic control flaggers and signs were present to notify motorists of work areas while crews worked along McCain Valley Road in accordance with the Traffic Control Plan (MM-TRA-1).

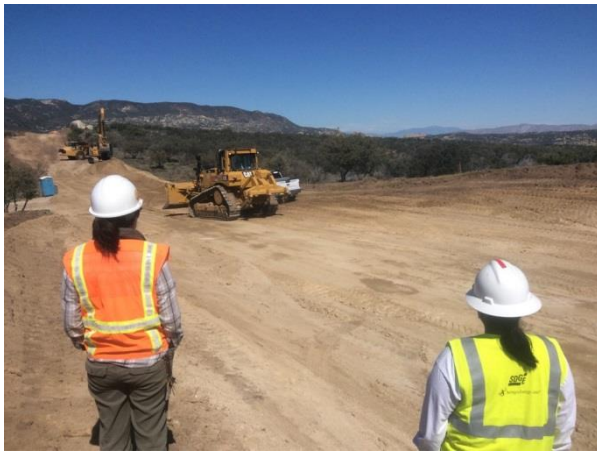
**Photo 7:** Archaeological and Native American monitors were present during grading activities along McCain Valley Road in accordance with MM-CUL-1D.

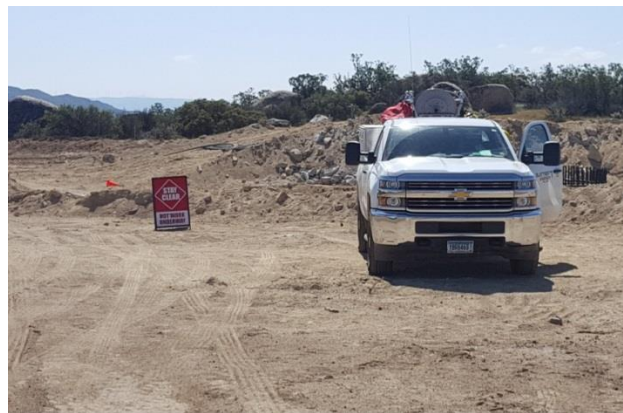
**Photo 8:** Fire safety coordinator and required signs were present during Hot Work at turbine pad G12 in accordance with the issued Hot Work Permit and MM-FF-1.

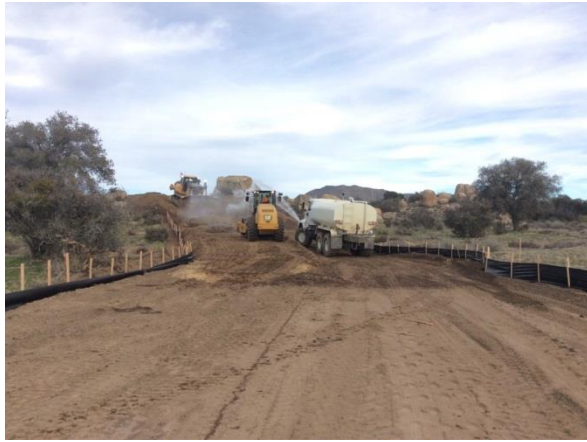
**Photo 1:** Clearing and grading activities observed within the staked limits of disturbance in accordance with MM BIO-1A. Water trucks in use for dust control in accordance with MM-AQ-1.

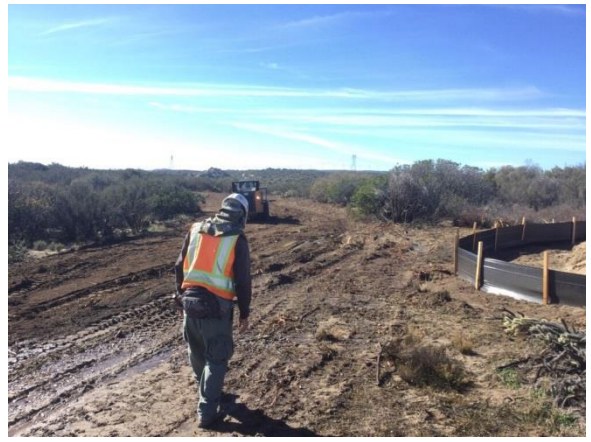
**Photo 2:** Cultural monitor observing clearing activities in accordance with MM CUL-1D.

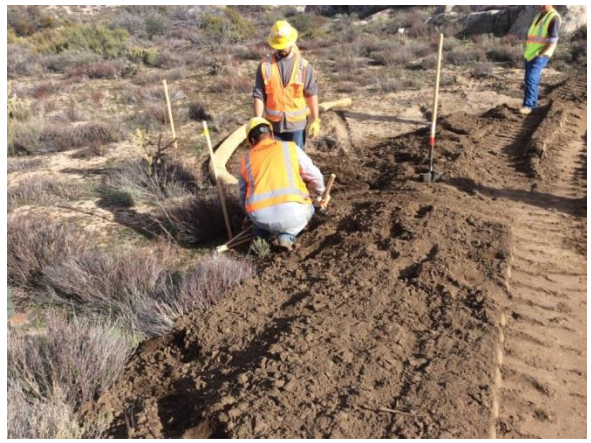
**Photo 4:** Crews installing additional straw wattles along McCain Valley Road in accordance with the SWPPP and MM HYD-1.

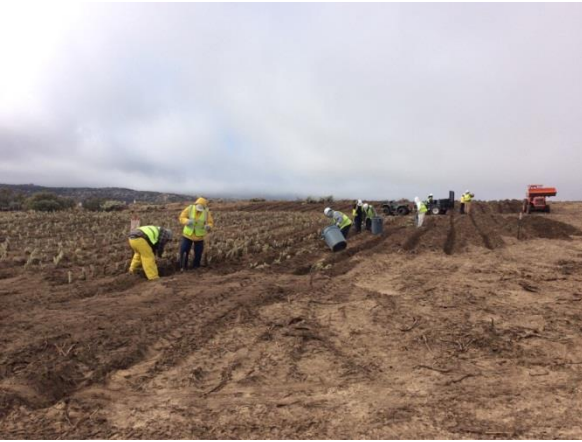
**Photo 1:** Previously salvaged cacti are being temporarily planted along the J string. The cacti are anticipated to be re-planted post-construction in accordance with Section 5.2.2.1 of the Habitat Restoration Plan.

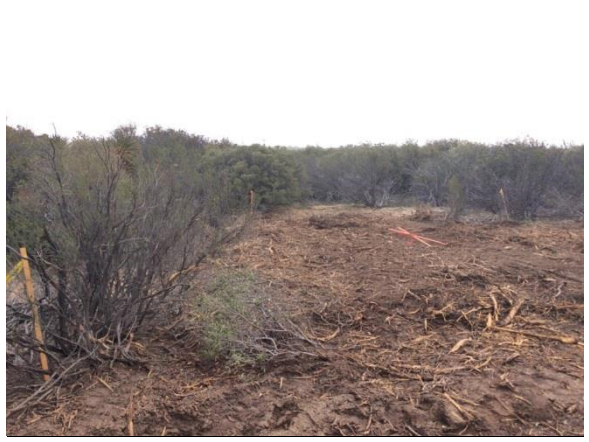
**Photo 2:** On 1.11.17, approximately 230 square feet of vegetation was mulched outside of the limits of disturbance. This event is being classified as a "Non Compliance" in accordance with Section 5.2 of the ECCMP.

| Incident Number | Date of Incident | Description of Incident | Description of Corrective Action |
|---|---|---|---|
| | | staked limits of disturbance along F string on lands administered by the BLM. Vegetation was mulched past the limits of disturbance by approximately 20 feet impacting approximately 230 square feet of vegetation. The operator cleared up to what he thought was the staked disturbance limit, but did not recognize that one of the stakes was an "offset" stake that was intentionally placed off the ROW. The BLM's third party compliance cultural and compliance monitors surveyed the area outside the disturbance limits and found no impacts to biological or cultural resources. | stakes have GPS locations recorded in the field, the contractor quickly assessed that a total of 45 offset stakes had been placed throughout the project. A new protocol was put in place requiring removing offset stakes and clarifying the limits of disturbance when a rock or other immobile object blocked appropriate stake placement. Specifically, these new protocols consist of staking on either side of the object at the clearing limits. |

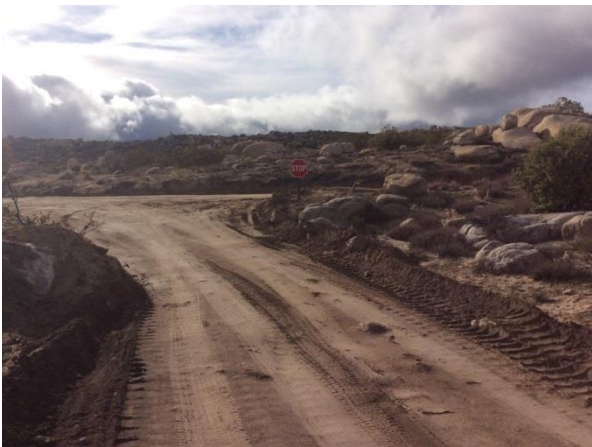
**Photo 3:** Stop sign installed along the H string access road AA in accordance with the approved Traffic Control Plan and MM TRA-1.

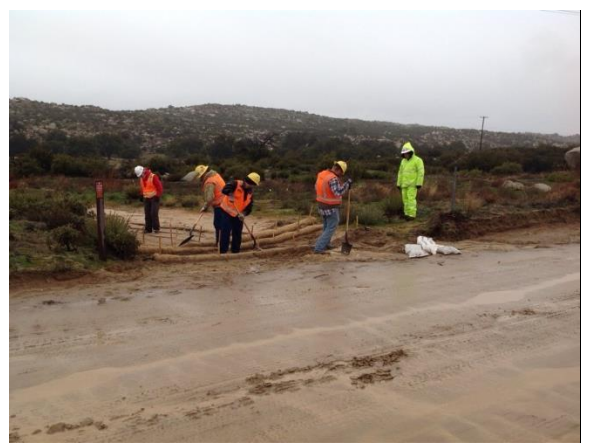
**Photo 4:** Crews installing additional straw wattles and maintaining existing erosion and sediment control devices along McCain Valley Road in accordance with the SWPPP and MM HYD-1. Cultural monitors were present to observe ground disturbance associated with the installation and maintenance of sediment control devices in accordance with MM CUL-1D.

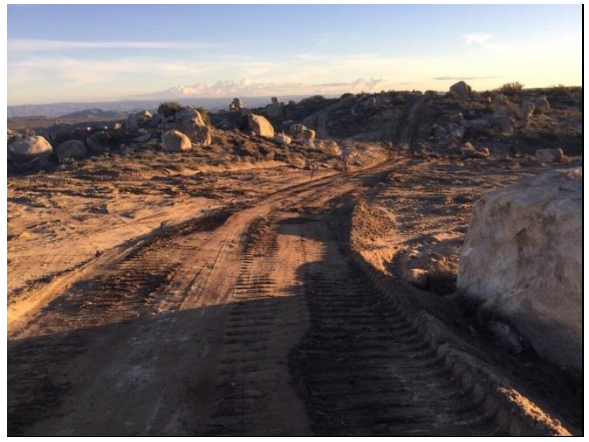
**Photo 2:** On 1.16.17, a BLM third party cultural monitor observed a blade operating in a previously disturbed area along the G string access road between structures G7 and G6 without a cultural monitor present. BLM issued a “Non Compliance” in accordance with Section 5.2 of the ECCMP.

| Incident Number | Date of Incident | Description of Incident | Description of Corrective Action |
|---|---|---|---|
| 05 | 1.16.17 | On Monday, 1.16.17, the BLM's third party cultural monitor observed a blade grading the G string access road between structures G7 and G6 in a previously disturbed area without cultural monitors present. The third party cultural monitor notified the lead archaeologist who sent an archaeological and Native American monitor to cover the activity. No resources were determined to be impacted as a result of this event. A serious violation was issued by the BLM for this incident due to a monitor not being present in an area that required monitoring per MM-CUL-1D. Tule Wind LLC is in the process of preparing a corrective actions memorandum to provide BLM with a process that will be implemented moving forward to minimize the potential for a similar incident to not occur in the future. | Tule Wind LLC shut down the site and the construction team began to brainstorm options to alleviate any confusion related to the need for monitors for previously disturbed areas. |

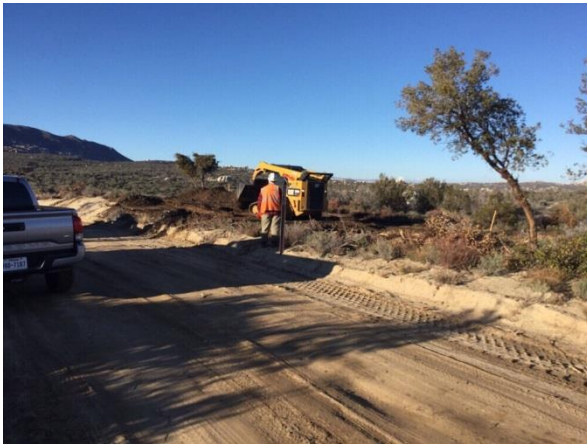
**Photo 3:** Cultural monitors were observed monitoring vegetation removal and grading activities along McCain Valley Road in accordance with MM CUL-1D.

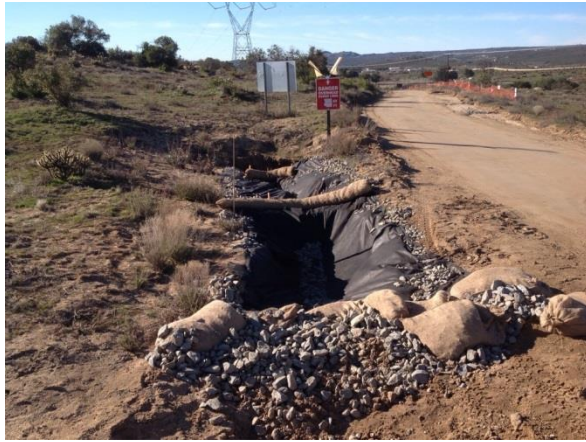
**Photo 1:** Crews began installing catch basins and rip-rap sediment and erosion control devices to replace damaged and failing straw wattles and sand/gravel bags in accordance with MM HYD-1 and the SWPPP. Photo shows a completed catch basin along McCain Valley Road where sediment was previously documented leaving the project site during SWPPP inspections.

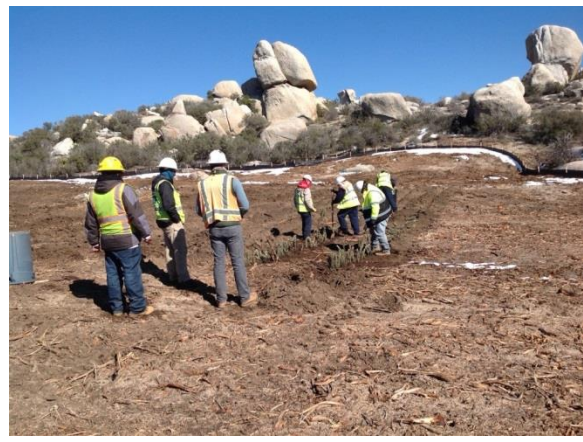
**Photo 2:** ECMs observed cultural and biological monitors/Habitat Restoration Specialists monitoring the planting of salvaged cacti at the E-String laydown area in accordance with MM CUL-1D and BIO-1C.

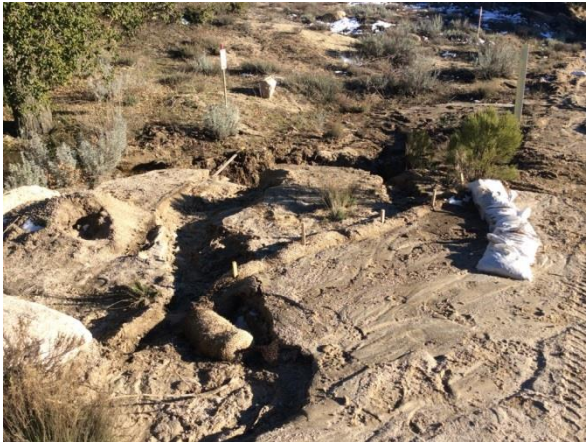
**Photo 3:** ECMs and SWPPP inspectors checked the project site for areas where erosion and sediment control devices were missing or failing. These issues were documented and reported to Tule Wind, LLC. During this reporting period, construction crews were onsite daily to repair, maintain, and install additional erosion and sediment control devices in accordance with MM HYD-1 and the SWPPP.

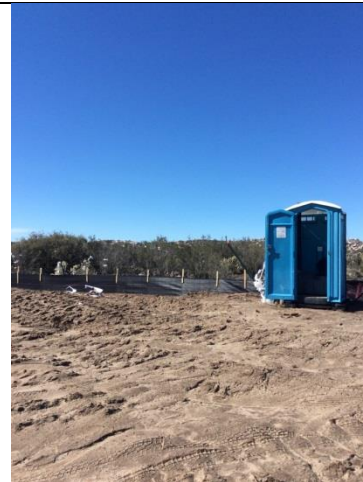
**Photo 4:** On Friday, 1.27.17 ECMs observed toilet paper, which had blown out of the portable sanitation facility at the H-String laydown area into nearby vegetation during the windy conditions (gusts over 40 mph). This issue has been recorded as a "Problem Area" according to Section 5.2 of the ECCMP. Biological monitors are anticipated to sweep the area to clean up all remaining litter in accordance with MM BIO-7D.

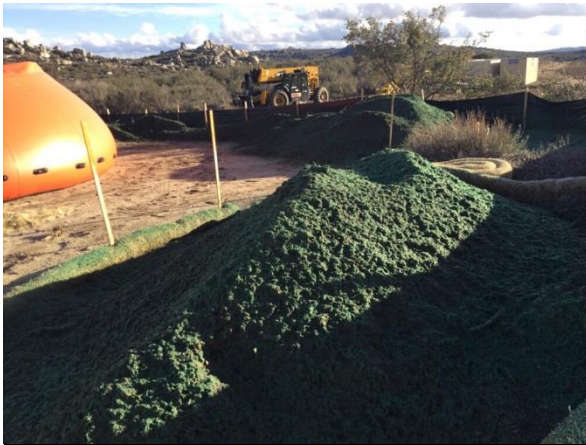
**Photo 3:** Hydromulch was applied to salvaged topsoil storage piles to prevent erosion in accordance with MM HYD-1 and the SWPPP.

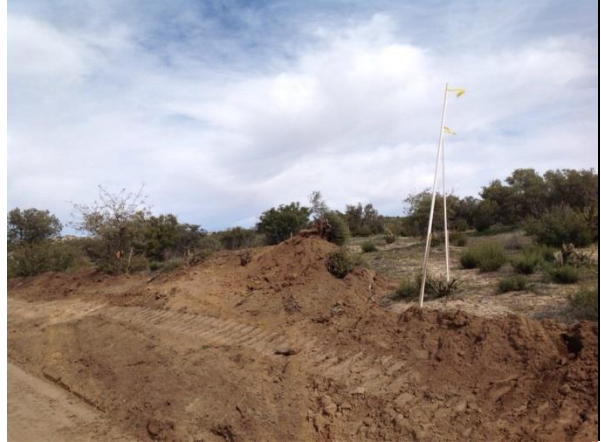
**Photo 2:** Contractor personnel added steel posts and PVC extensions where needed to give equipment operators greater visibility of limit of disturbance markers in response to the noncompliance event on February 9, 2017 (described in the caption of Photo 1).

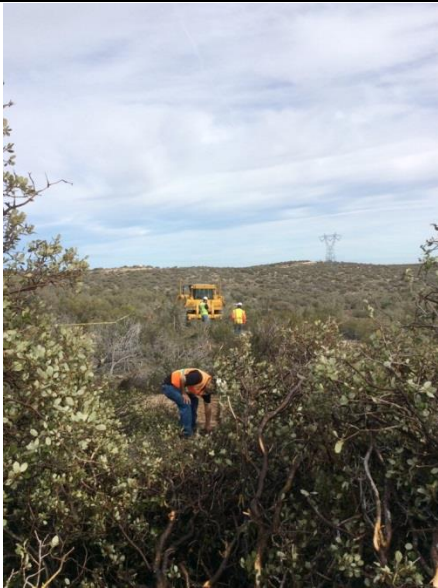
**Photo 3:** Resource monitors and equipment operators cut pre-grubbing lines in thick vegetation along the yellow tape disturbance limits with monitors acting as spotters ahead of the equipment in accordance with the February 1, 2017 NTP.

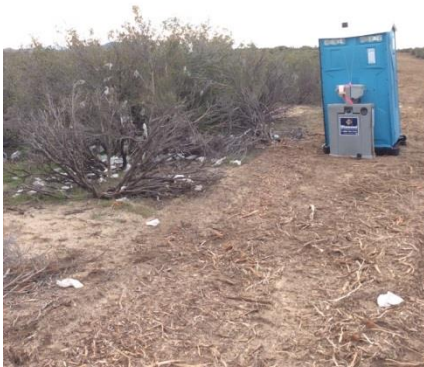
**Photo 1:** On February 14, 2017, the portable sanitation facility at the F-String access road had toilet paper blow into nearby vegetation during a period of high winds. ECMs notified the designated biologist and the litter was removed upon notification.

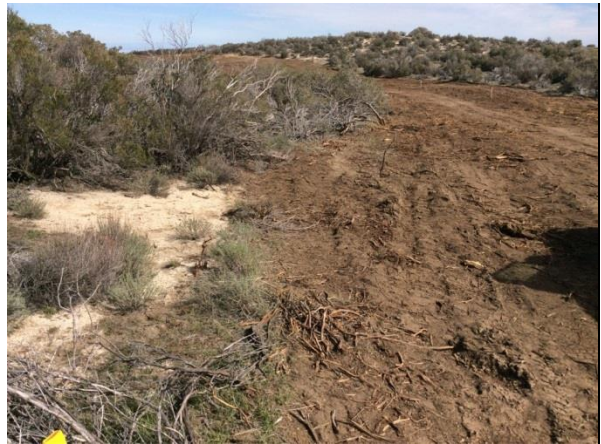
**Photo 2:** On February 9, 2017, a breach of the approved limits of disturbance along the C-String was observed.

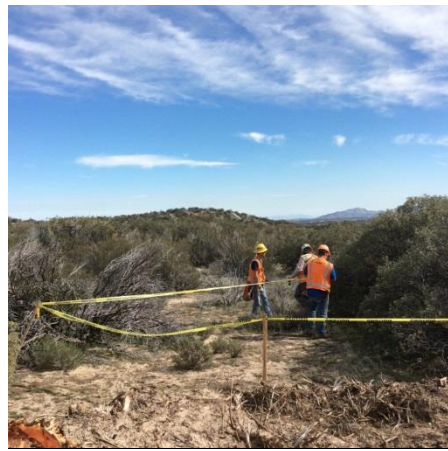
**Photo 4:** Crews observed verifying disturbance limit stake locations and installing yellow tape prior to the start of disturbance activities in accordance with the NTP issued February 1, 2017.

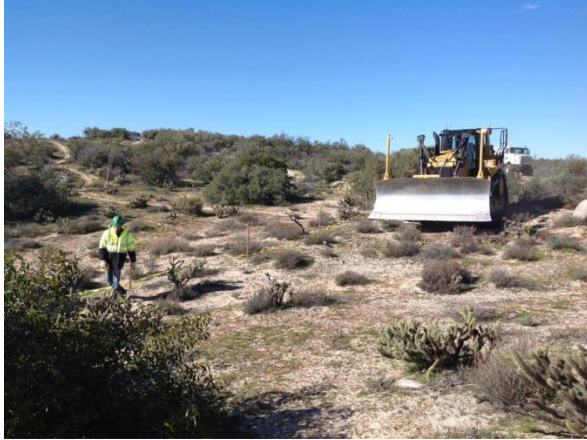
**Photo 1:** Spotters walked ahead of bulldozer operators who cleared large vegetation along the taped disturbance limits ahead of grubbing activities to help increase visibility for masticator operators in accordance with the February 1, 2017 NTP.

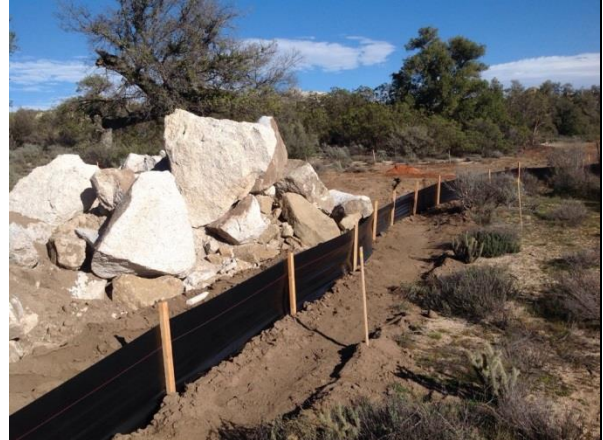
**Photo 2:** During this reporting period, crews repaired a damaged silt fence on the McCain Valley cutoff road per direction provided by the QSP and ECMs in accordance with the SWPPP.

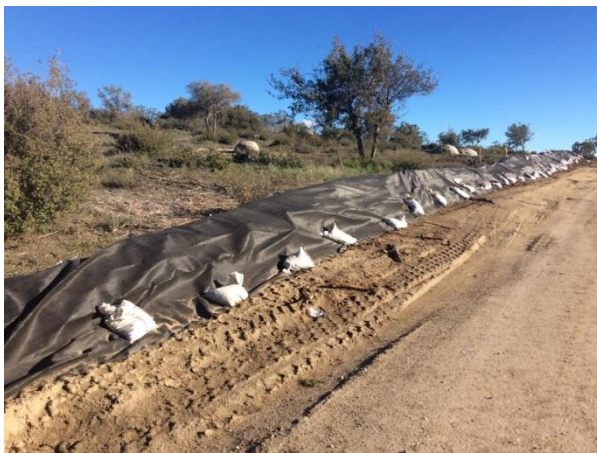
**Photo 3:** ECMs observed windrowed topsoil salvage stockpiles along McCain Valley Road covered in fabric secured with sand bags in accordance with the SWPPP.

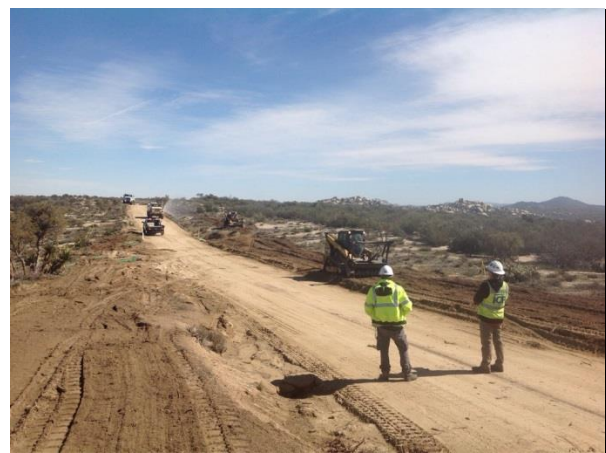
**Photo 4:** Biological, archaeological, and Native American monitors were present during road widening activities along McCain Valley Road in accordance with MM CUL-1D and BIO-1C. Water was applied regularly to reduce dust in accordance with the Dust Control Plan and MM AQ-1.

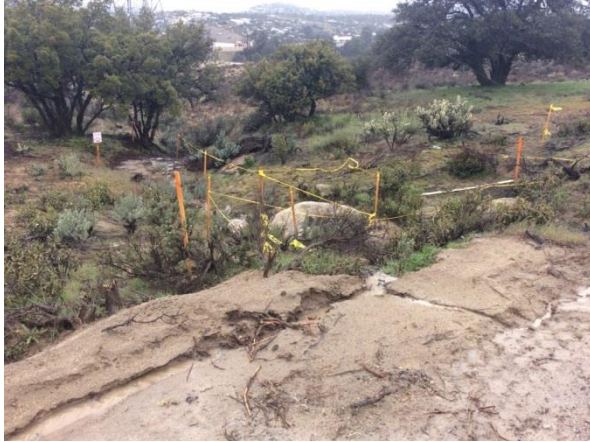
**Photo 1:** ECMs and SWPPP monitors observed and reported locations along McCain Valley Road where recent grading activities changed the path of overland flow and additional BMPs are required to ensure sediment remains on the ROW. Tule Wind, LLC had BMP installation and maintenance crews onsite to resolve these issues during this reporting period.

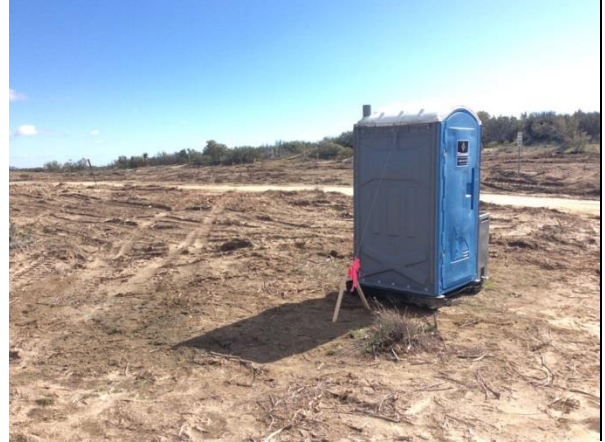
**Photo 2:** The portable restroom which had blown over during a period of high winds on February 27, 2017 was turned upright and staked the following day to prevent the issue from reoccurring. The stained soil was removed in accordance with MM HAZ-1A.

On January 6, January 27, and February 27, 2017 portable sanitation facilities, which were previously secured, were discovered overturned. ECMs observed fluid discharge from each of the overturned facilities. The stained soil was contained and removed from the site in accordance with Section 8.3 of the Hazardous Materials Management Plan. The facilities were righted and secured. During this reporting period, Tule Wind LLC began securing portable sanitation facilities with wire to more securely affix the facilities to the ground surface and prevent theft or vandalism.

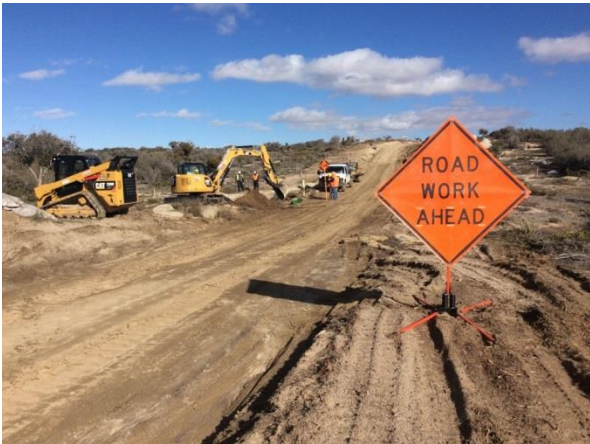
**Photo 3:** Traffic control flaggers and signs were present to notify motorists of work areas while crews worked along McCain Valley Road in accordance with the Traffic Control Plan (MM TRA-1).

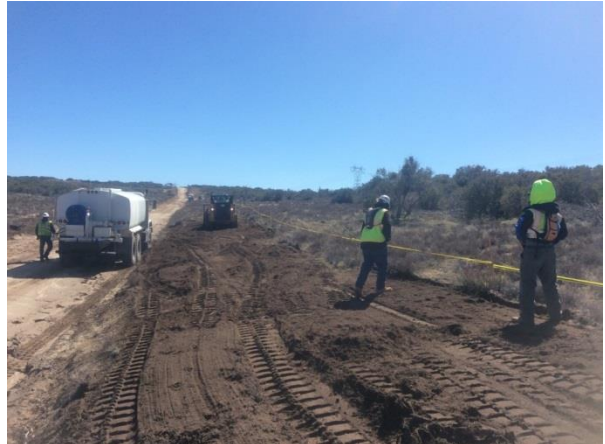
**Photo 4:** Archaeological and Native American monitors were present during road widening activities along McCain Valley Road in accordance with MM CUL-1D. Water was applied regularly to reduce dust in accordance with the Dust Control Plan and MM AQ-1 and disturbance limits were demarcated with yellow tape in accordance with the February 1, 2017 NTP.

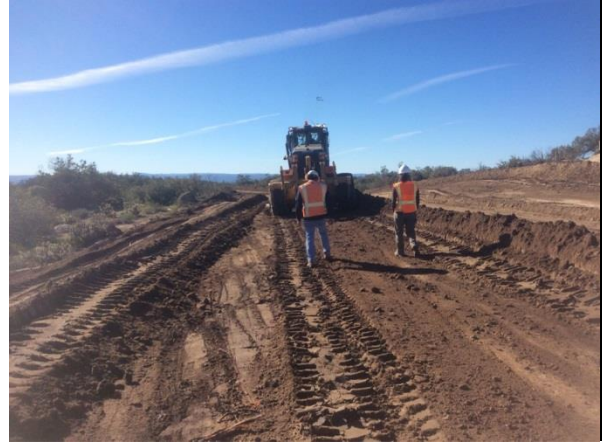
**Photo 2:** Archaeological and Native American monitors were present during grading activities along the G-String in accordance with MM CUL-1D.

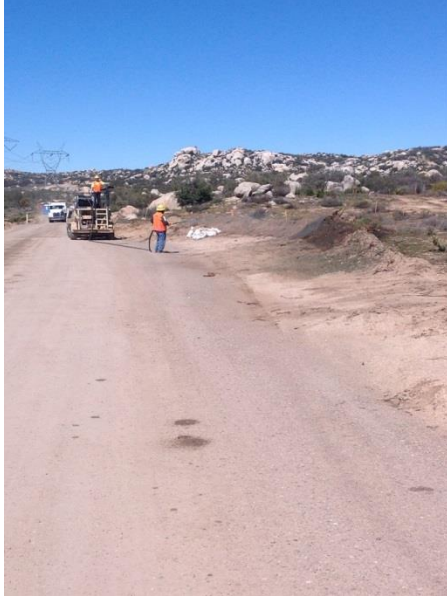
**Photo 3:** ECMs observed construction crews hydromulching topsoil salvage windrows along McCain Valley Road in accordance with the SWPPP.

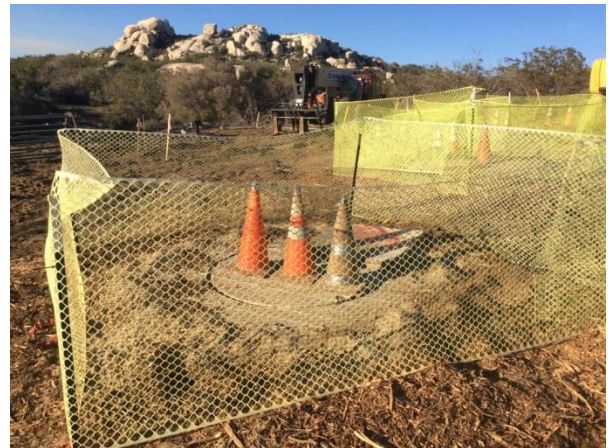
**Photo 4:** The meteorological tower foundation excavations were covered when not in use to avoid trapping or injuring wildlife in accordance with MM BIO-7A.

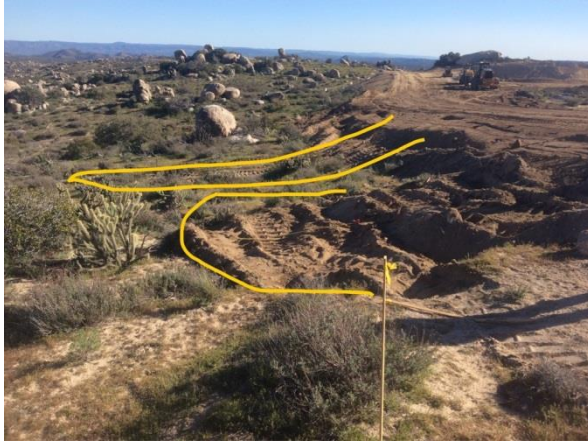
**Photo 1:** On March 13, 2017, disturbance beyond the staked limits of disturbance occurred when a piece of construction equipment hit a subsurface rock and lost control. The area of disturbance was inspected and it was determined that no damage to sensitive environmental resources occurred.

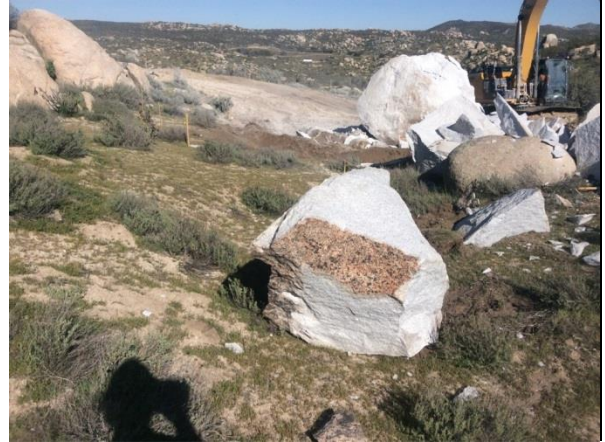
**Photo 2:** During blasting activities on March 16, 2017, rock debris fell approximately 10 feet outside the staked disturbance limits. The pieces of rock were left in place to avoid creating additional unauthorized disturbance.

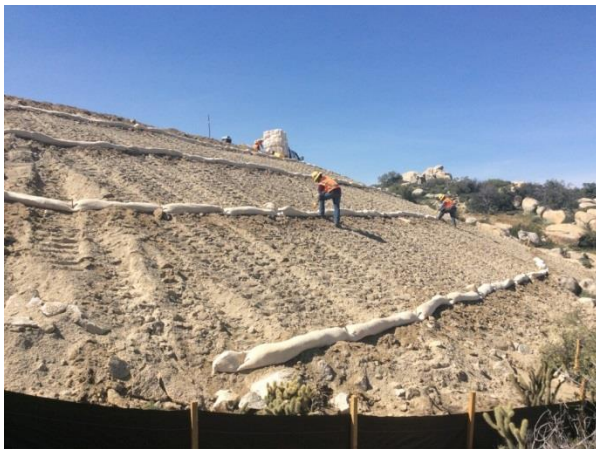
**Photo 3:** ECMs observed construction crews installing biodegradable and weed-free straw wattles at the H1 turbine pad in accordance with the SWPPP and per direction from the BLM, CDFW, and State Water Board.

During the week of March 6<sup>th</sup> the BLM, California Department of Fish and Wildlife (CDFW), and the California State Water Resources Control Board instructed Tule Wind LLC to discontinue the use of all plastic encased straw wattles. Tule Wind LLC has ordered biodegradable weed free straw wattles that are being used to replace the existing plastic encased straw wattles that have already been installed. The removed plastic encased wattles are being hauled off site for disposal. The biodegradable straw wattles will be used to avoid wildlife from becoming entrapped in the plastic casing and to prevent plastic debris at the conclusion of construction activities.

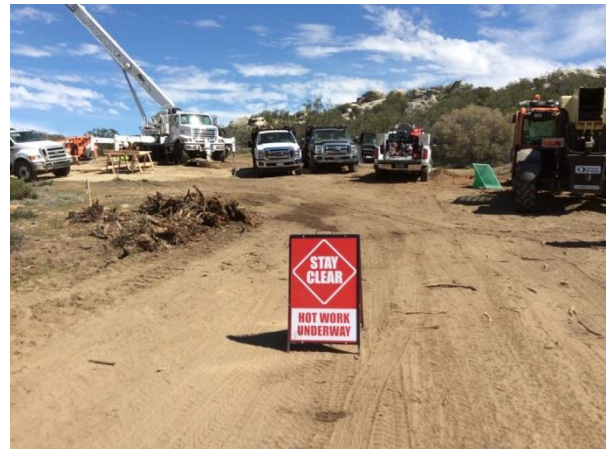
**Photo 4:** Required equipment and warning signs were present at the Transmission Line Pole 4 during hot work activities in accordance with the issued hot work permit and the Fire Prevention/Protection Plan (MM FF-1).

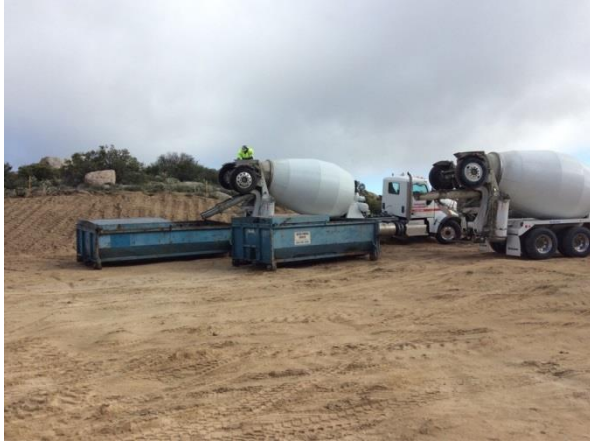
**Photo 1:** Concrete washout containers were used during foundation pouring activities to ensure contaminated discharge was contained in accordance with MM BIO-5.

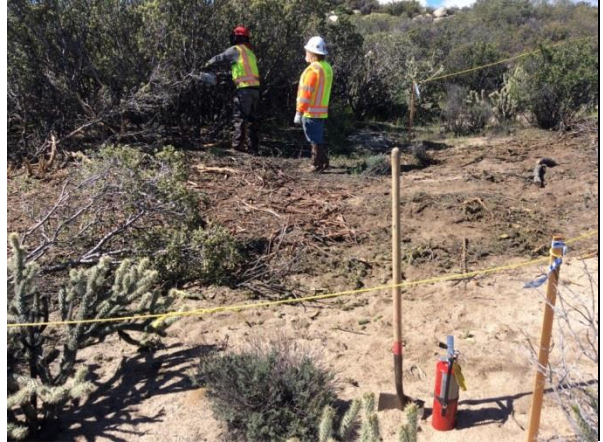
**Photo 2:** Fire prevention equipment was staged within 30 feet of chainsaw work along the collection line in accordance with the Fire Prevention/Protection Plan (MM FF-1).

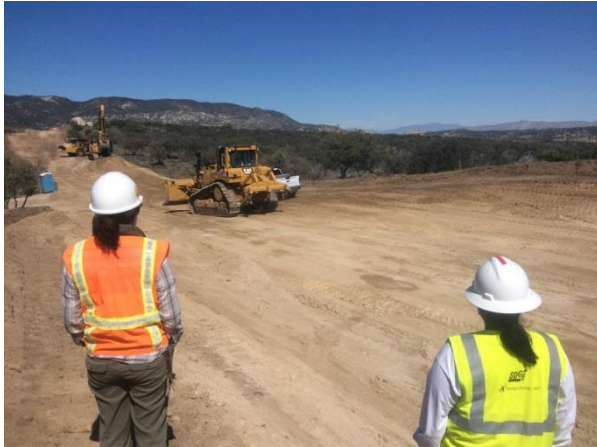
**Photo 3:** Archaeological and Native American monitors were present during grading activities along McCain Valley Road in accordance with MM CUL-1D.

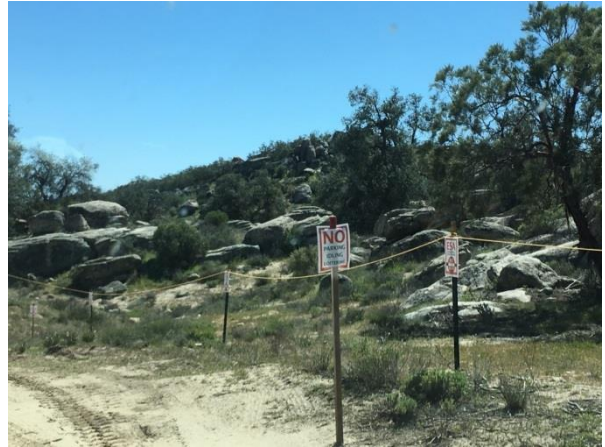
**Photo 4:** ECMs confirmed that no-disturbance buffers have been installed to minimize impacts to nesting birds in accordance with MM BIO-7J.

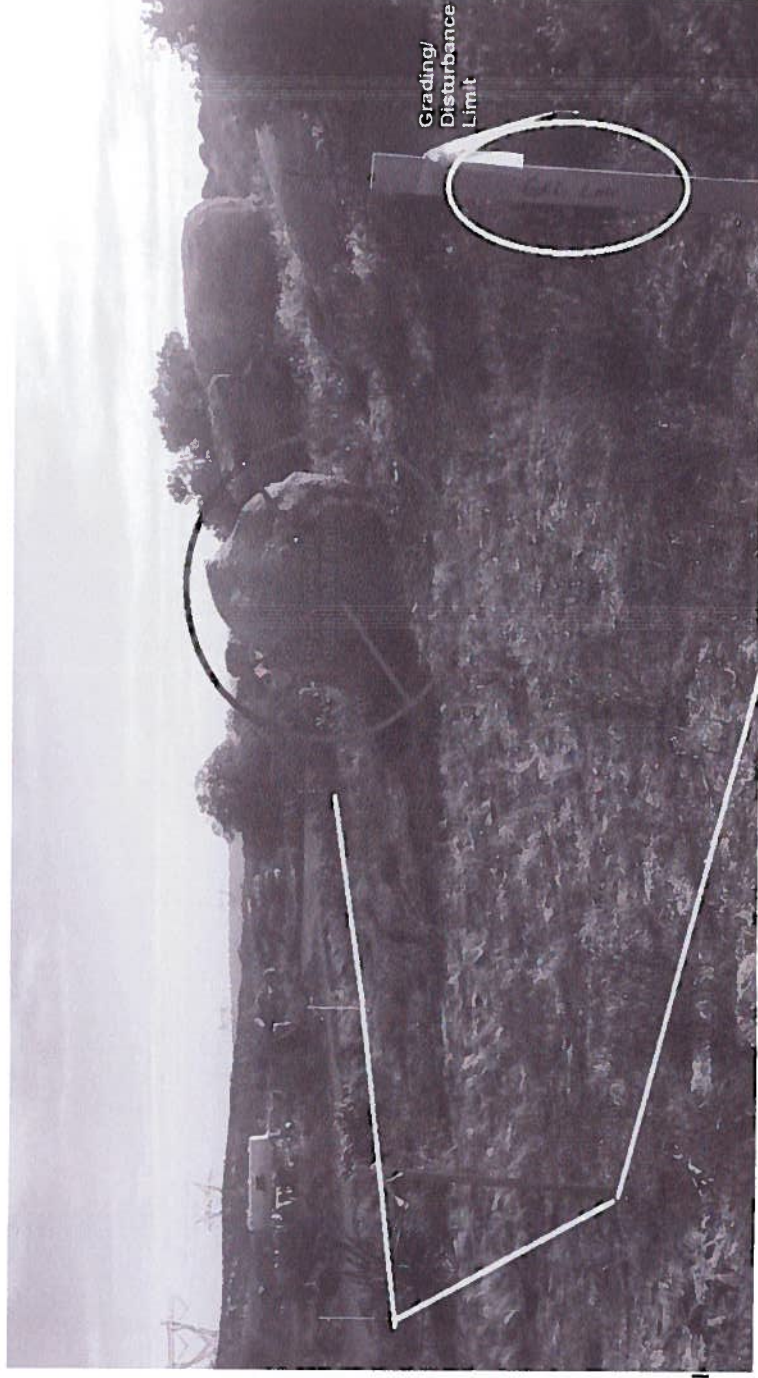
# Disturbance Limits

- Below is an example of the staking for our grading/disturbance limits. As well as an example of what not to do to stay in compliance. It is critical to the project that we take all necessary actions to stay within compliance.
- The blatant disregard for complying with any limit requirements will result in disciplinary action.
